**RE: Test Pit Summary Report
Thorndike Place Stormwater Peer Review**

TEST PIT SUMMARY REPORT

**THORNDIKE PLACE
DOROTHY ROAD
ARLINGTON, MA**

JULY 2023

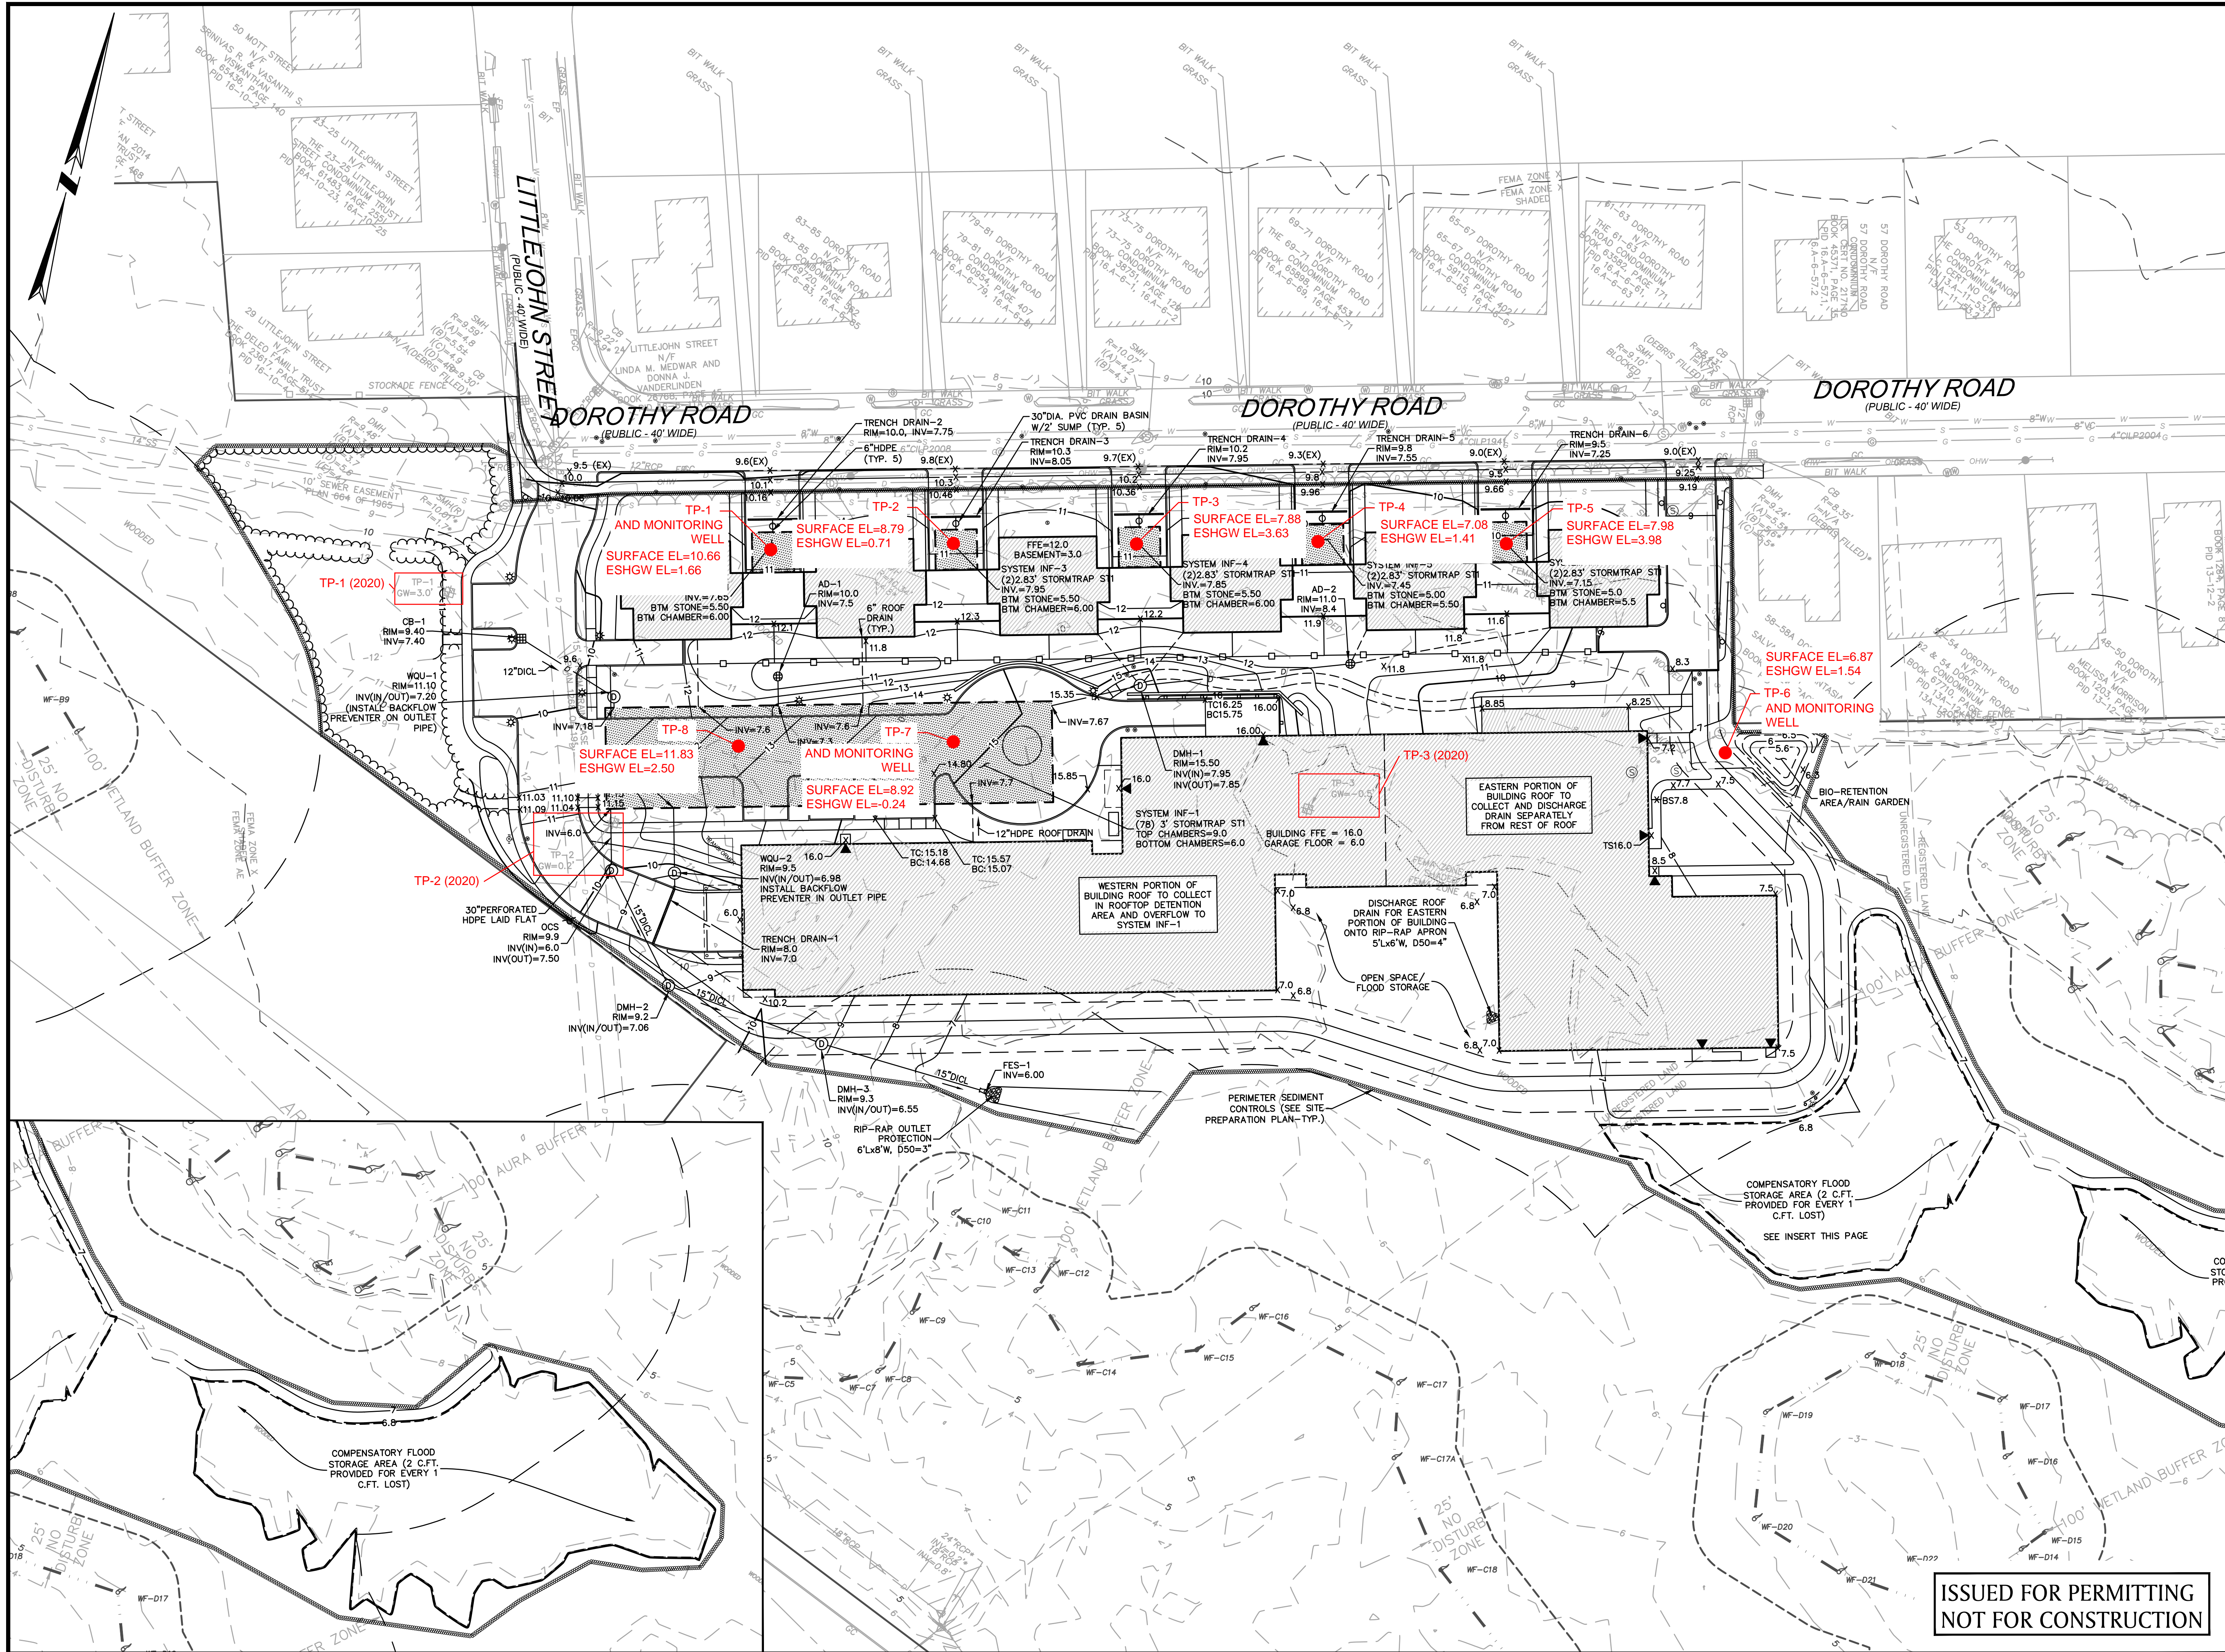
TEST PIT MAP

Standing and/or weeping groundwater was found in all test pits at depth varying from 60 to 112-inches below existing grade. Additionally, redoximorphic (redox) features, indicating the presence of seasonal high groundwater, were observed in three of the test pits – TP-3, TP-5, and TP-6. These redox features were found at depths between 48 and 64-inches below existing grade. The table below summarizes the test pit results. Where redox features were observed, these have been used to identify ESHGW elevations. Where no redox features were observed, the depth to observed groundwater has been used to identify ESHGW elevations.

Test Pit	Existing Grade	Total Depth (in.)	Depth Fill (in.)	Depth Observed GW (in.)	Depth to Redox (in.)*	ESHGW
TP-1	10.66	120	90	108	n/a	1.66
TP-2	8.79	104	83	97	n/a	0.71
TP-3	7.88	87	27	82	51	3.63
TP-4	7.08	96	64	68	n/a	1.41
TP-5	7.98	74	33	60	48	3.98
TP-6	6.87	132	30	110	64	1.54
TP-7	8.92	114	108	110	n/a	-0.24
TP-8	11.83	120	120	112	n/a	2.50
